HO-1040 Rep. Stephen Gambrill House 9881 Gorman Road Private

# Maryland Historical Trust Maryland Inventory of Historic Properties Form

Inventory No. HO-1040

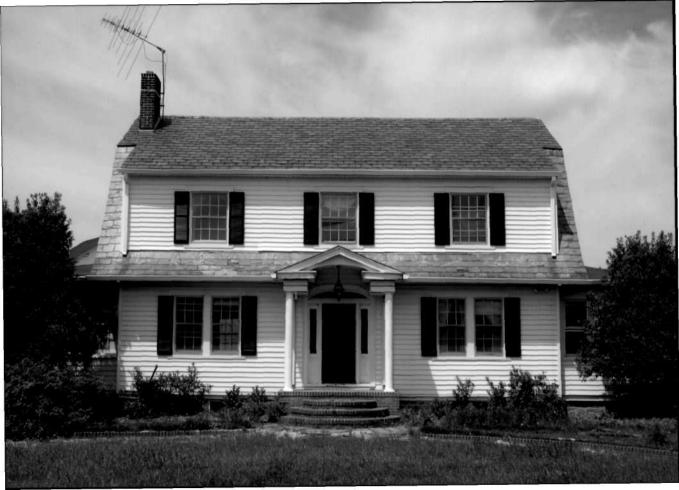
HO-1040\_2011-05-10\_01 East elevation

HO-1040 Rep. Stephen Gambrill House 9881 Gorman Road Howard County, Maryland Ken Short 2011-05-10 MD SHPO East elevation 10+8

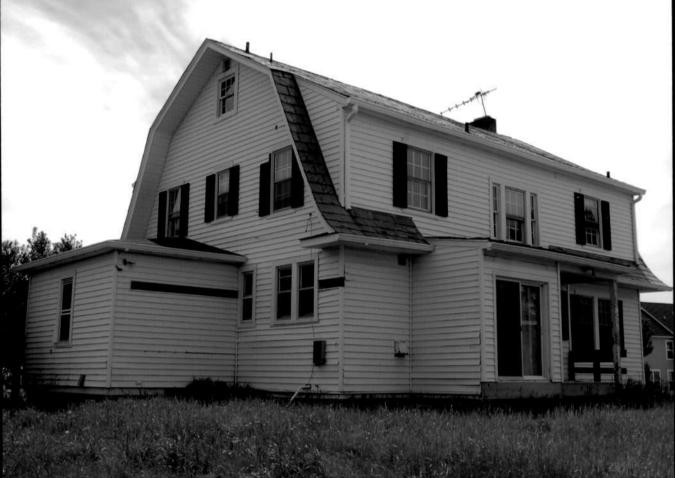
The north elevation, on the first story, has the north wing covering the east and center bays. This wing has a single six-over-six sash. Just west of the wing is a one-over-one sash with leaded diamond lights, and the west bay has paired one-over-one sash with leaded diamond lights. The second story has a four-over-four sash in the center, with a six-over-six sash in the east and west bays. The gambrel end has a single six-over-six sash.

HO-1040\_2011-05-10\_02 North & west elevations

HO-1040 Rep. Stephen Gambrill House 9881 Gorman Road Howard County, Maryland Ken Short 2011-05-10 MD SHPO North+west elevations 2 of 8

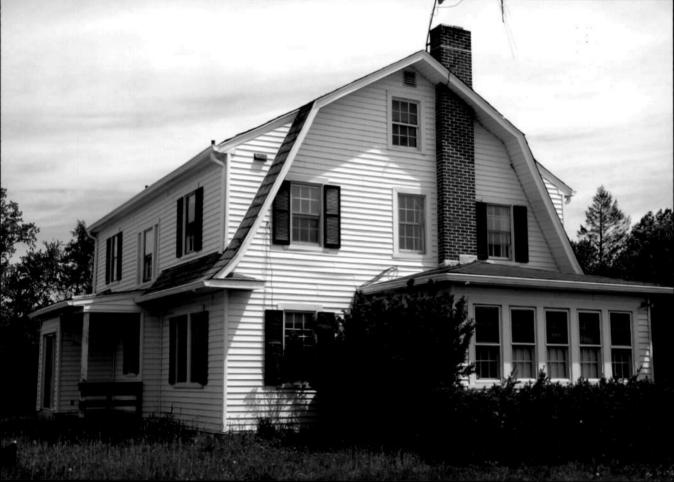
On the south elevation the first-story west bay has a six-over-six sash and the center and east bays are the south wing; this wing contains five six-over-six sash. The second story has three six-over-six sash, and the gambrel end has a single six-over-six sash. On the west elevation, the first story has a two-bay porch with a shed roof of standing seam metal, in the north and center bays. The north bay of the porch is enclosed with a modern glass slider, and the center bay has a six-over-six sash. The south bay of the house has paired six-over-six sash. The upper story has a six-over-six sash in the center with a two-over-two sash to each side, creating a triple sash. The north and south bays have a six-over-six sash. On the west elevation, the south wing has a pair of French doors with ten lights each. The north wing has no openings on the west elevation.

HO-1040\_2011-05-10\_03 West & south elevations

HO-1040 Rep. Stephen Gambrill House 9881 Gorman Road Howard County, Maryland Ken Short 2011-05-10 MD SHPO West + south elevations 3 0 9

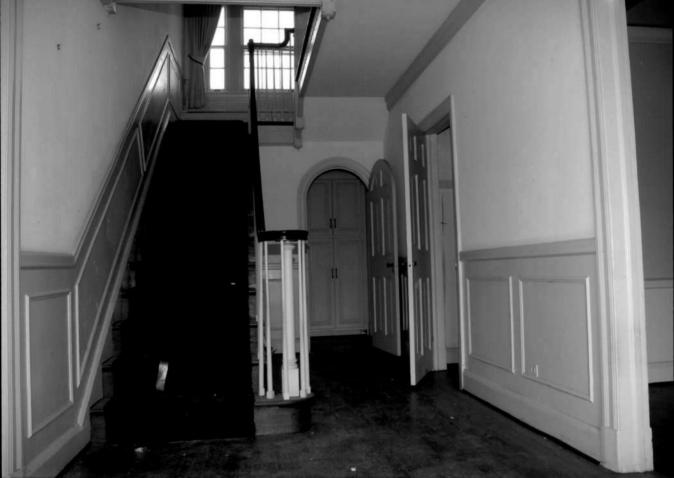
The interior has a center-passage, single-pile plan to the south of the passage, and a double-pile plan to the north of the passage, with a one-room wing on both the north and south ends. The passage has 2½-inch oak tongue-and-grooved flooring that runs east-west, and this flooring runs through the north and south rooms and the south wing. The first story walls are plaster on lath. The passage has half-paneling of applied panels, with chair rail, and the chair rail has two reeds in the center of it. The architrave has a fillet and ogee backband and an ogee on the inner edge. The front door is hung on butt hinges with ball finials and has a new lock. There is a wide opening on both the north and south walls, and the north wall had doors that are now missing. There is a closet on the north elevation, and it has a six-panel door with sunken fields. The west wall has a semi-circular-arched six-panel door that leads to a cross-passage, and it is set beneath the stair landing. The doors have brass knobs and mortise locks. The passage has a wood cornice with a large ogee above a small cavetto. There is a plaster ceiling medallion of acanthus leaves with a band that has fluting around the outside. There is an open stringer stair on the south wall that ascends to a landing at the west end. It has turned, tapered balusters and a curtail step with Doric column newel post in the center. There are sawn scroll brackets and drop pendants on the bottom of the newel post. The apron on the stair landing has a fish-scale pattern.

HO-1040\_2011-05-10\_04 Passage, view north

HO-10HO Rep. Stephen Gambrill House 9881 Gorman Road Howard County, Maryland Ken Short 2011-05-10 MD SHPO Passage, view north 40f8

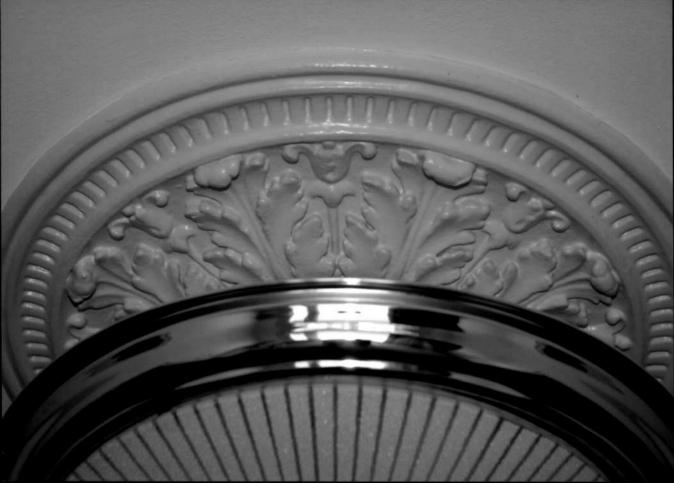
HO-1040\_2011-05-10\_05 Passage ceiling medallion

HO-1040 Rep. Stephen Gambrill House 9881 Gorman Road Howard County, Maryland Ken Short 2011-05-10 MD SHPO Passage ceiling medallion 50f8

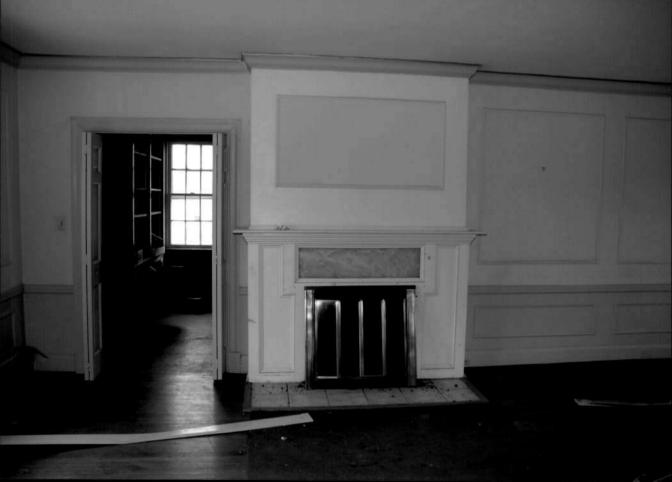
The south room has typical architrave, chair rail with applied panel moulds above and below it, and typical cornice. The cornice projects into the room above the windows to form a valance. The wood sash date to the 20<sup>th</sup> century and have ovolo muntins and 9-inch by 13-inch lights. They are hung on cords. There is a fireplace on the south elevation, set east of center, with a new hearth and a brick firebox with splayed jambs. There is a wood mantel with an "L" shaped panel on each side and a

marble frieze. The bed mould has two ogees and bevels. The mantel projects into the room about 9 inches, and the mantel shelf wraps around both sides of this projection. There are bi-fold doors on the south elevation, to the east of the fireplace, and they appear to be original; they lead to the south wing. The south wing floor is continuous, and it has modern paneling and a drop ceiling. There are new built-in oak shelves, some with glass doors. The windows match those in the south room, and there are French doors on the west elevation.

HO-1040\_2011-05-10\_06 South room, south elevation

40-1040 Rep. Stephen Gambrill House 9881 Gorman Road Haward County, Maryland Ken Short 2011-05-10 MD SHPO South room, south elevation 6 of 8

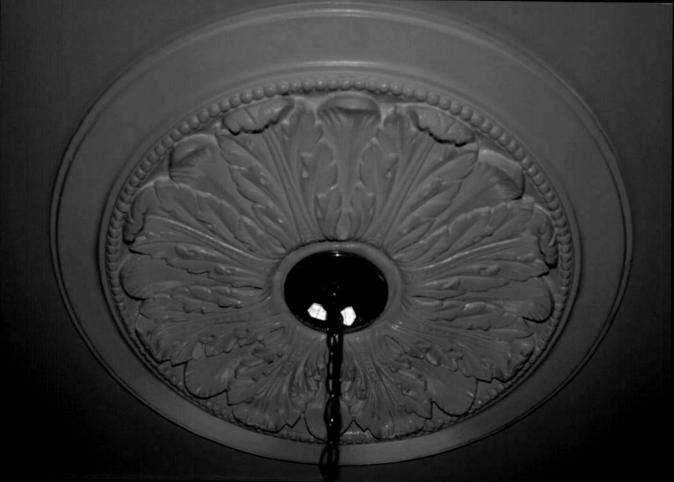
The northeast room has typical architrave, chair rail, cornice, and windows. There is a plaster ceiling medallion that appears to be original, and has acanthus leaves with a bead mould around the outside of it and a plain field outside of that. There are bi-fold doors on the north elevation that match those in the south room, and appear to be original; they lead to the north wing. There is a swinging door on the west elevation, set to the north, which leads to the kitchen, it has six panels. The north wing floor level is set several inches lower than the rest of the house, and there is carpeting here over top of quarry tile. It has later 20th century wood sash, has paneling, and has a textured plaster ceiling. There is a new built-in cupboard and shelf unit on the west end of the room.

HO-1040\_2011-05-10\_07 Northeast room, ceiling medallion

40-1040 Rep. Stephen Gambrill House 9881 Gorman Road Howard County, Maryland Ken Short 2011-05-10 MD SHPO Northeast room, ceiling medallion 70f8

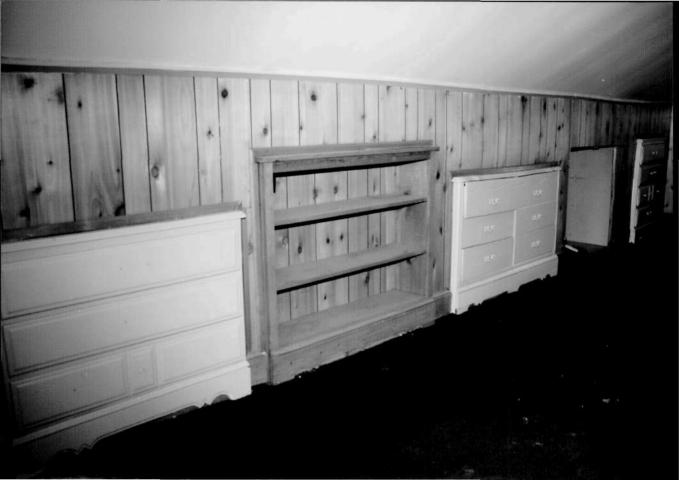
The attic contains two finished rooms. The stairs ascend into the south room, which has paneling, carpeting, and built-in drawers and shelves on the east elevation. There is a wall and door between the two rooms, made of painted knotty pine paneling. The north attic room is covered with drywall. The rafters are nominal 2 by 6s. There is new wood sash in the attic.

HO-1040\_2011-05-10\_08 Attic built-ins

HO-1040 Rep. Stephen Gambrill House 9881 Gorman Road Howard County, Maryland Ken Short 2011-05-10 MD SHPO Attic built-ins 8 of 8
